Technical Information	Date: 16.11.2023 Official: Heckl Department: BT-FS/MKP3
------------------------------	---

Tech. Information No.	2557/ 2023
Subject:	Possible wrong wiring on power supply holder on AVENAR panel and FPP-5000 / Power Supply housings

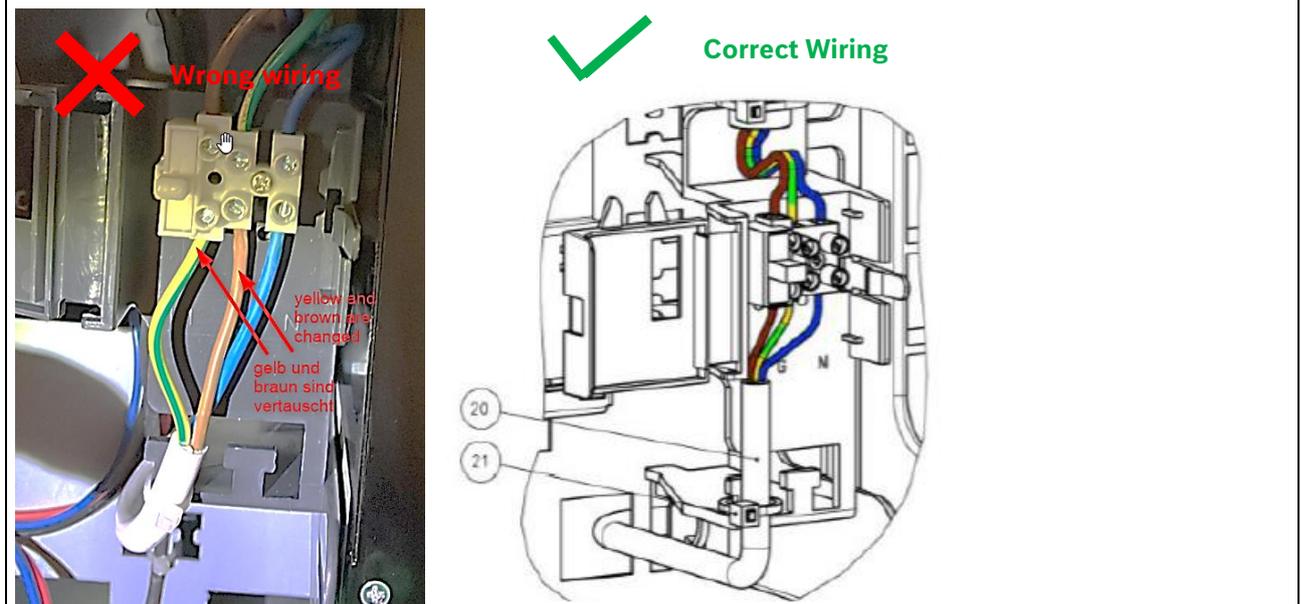
Short Description:	<p>Wrong wiring on a power supply holder was detected on two FPP-5000 (see TI 2554 / 2023). At this stage of investigation, it cannot be ruled out that the same error may occur at other frame mount housings. As a precautionary measure the warning for technicians has been extended to the listed products below.</p> <p>Attention life safety risk: Electrical hazard may occur!</p> <p>Successfully commissioned installations are not affected.</p>
---------------------------	--

For all new installations, it is essential to check the wiring before connecting to mains voltage. In case of incorrect wiring, the product must not be installed or put into operation (risk of electric shock!). Do not install the product until the wiring has been professionally corrected.
