<b>Technical Information</b>	Date: 06.11.2023 Official: Heckl Department: BT-FS/MKP3
------------------------------	---------------------------------------------------------------

<b>Tech. Information No.</b>	2554 / 2023
<b>Subject:</b>	FPP 5000 / Wrong wiring on power supply holder

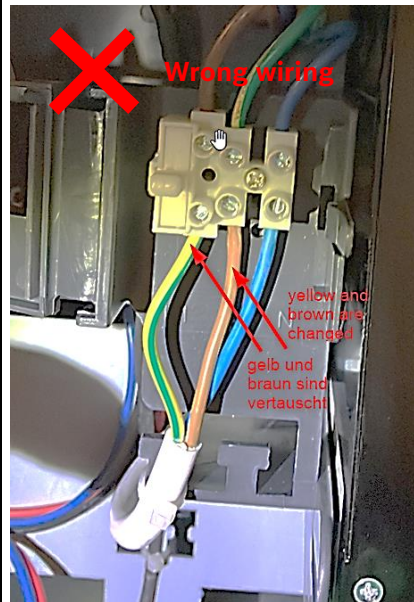
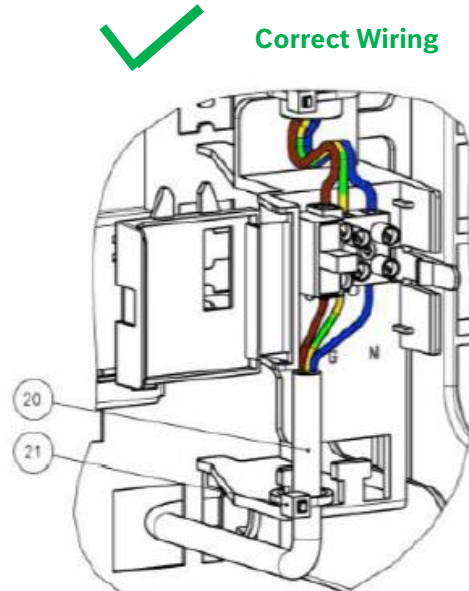
<b>Short Description:</b>	<p>On a FPP 5000 a wrong wiring on power supply holder was detected. In the pre-installed cable, the L1 (brown wire) and protective ground (green-yellow wire) were mixed up.</p> <p><b>Attention life safety risk:</b> Electrical hazard may occur!</p> <p>Successfully commissioned installations are not affected. a</p>
---------------------------	-----------------------------------------------------------------------------------------------------------------------------------------------------------------------------------------------------------------------------------------------------------------------------------------------------------------------------

For new installations, before connecting the power supply unit to mains voltage, the correct internal wiring of the power cable needs to be checked. If the error pattern occurs, the wiring has to be changed to the correct wiring.
